# the OUTRIGGER

#### R. Baker Specializes in Curtain Wall Dismantling and Demolition

#### Focus On Equipment: The Ring Crane

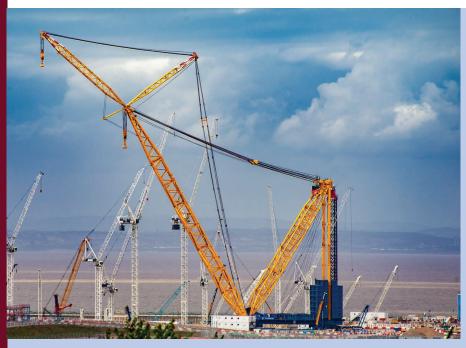
The ring crane is a type of luffing jib heavy-lift crane with a broad, round track at its base that allows the slewing while carrying extremely heavy loads. Ring cranes, which are relatively uncommon, have long reach and a small footprint and can lift as much as 5,000 tons. They are typically used in the construction of refineries, oil and gas, mining, offshore platforms, and nuclear power plants.

The world's largest construction crane is a ring crane known as "Big Carl", a Sarens SGC-250 currently being used in the UK to construct the Hinkley Point C nuclear power plant. Over the course of the project, which is expected to be completed by 2025, the crane will be used to lift more than 600 prefabricated sections including main sections of the steel containment liner and

reactor building domes. Big Carl can lift 5,000 tons on the 160m main boom and has a 52m jib that can be expanded up to 100m, giving a maximum height of 250m and a radius of 275m.

It took 280 trucks to transport the crane piece-by-piece from Belgium to the UK and ten weeks for reconstruction using five smaller cranes. Fifty-two of the containers used to transport the pieces were filled with locally sourced ballast are being used to provide counterweights, each weighing 100 tons. Ground pressure remains under 25 tons per square meter due to the large number of wheels on the four bogies that run on the 48.5m double ring beam and the 80 spreader mats the crane uses. Big Carl has 128 wheels for slewing and lifting and 96 wheels for traveling. Ordinarily, ring cranes remain stationary, but due to the large scale project, 6km of rail track was constructed at the site to allow the fully-rigged crane to travel between separate lifting locations, an industry first.

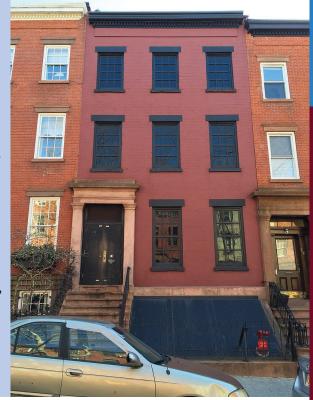
revival townhouse seems out of place, but passersby who take a closer look might notice the odd vacantness, the blacked-out windows, the industrial-looking front door. The truth is, the building is a false front for a subway emergency exit and ventilation shaft.

"Shaft House", as neighbors have nicknamed the building, was built in 1847 as a private home and was later converted to a multi-family dwelling. When subway service was expanded into Brooklyn in 1908, it was purchased and gutted by the IRT, converted to a fan plant, and outfitted with industrial steel louvers to vent air and smoke from the tunnel below. The New York City Transit Authority acquired the property in 1953, and in 1999 they began a major renovation of the building that included replacement of antiquated ventilation equipment and updating the façade to blend in with its neighbors. Installation of a penthouse air outlet allowed replacement of the unattractive louvers with faux black Lexan windows.

Those who been inside the cavernous, windowless interior of 58 Joralemon describe a collection of electrical panels, switches, catwalks, and ventilation shafts. Dimly-lit metal stairs descend nine stories to the track bed of the 4 and 5 subway and serve as an escape route in case of emergency. Fans the size of cars can be activated from a remote location to supply fresh air or expel smoke and heat in the event of a fire.
