the OUTRIGGER

R. Baker & Son Magazine

R. BAKER & SON Sulphur Recovery Unit (SRU) Dismantlement Project

ConocoPhillips Bayway Refinery – Linden, NJ

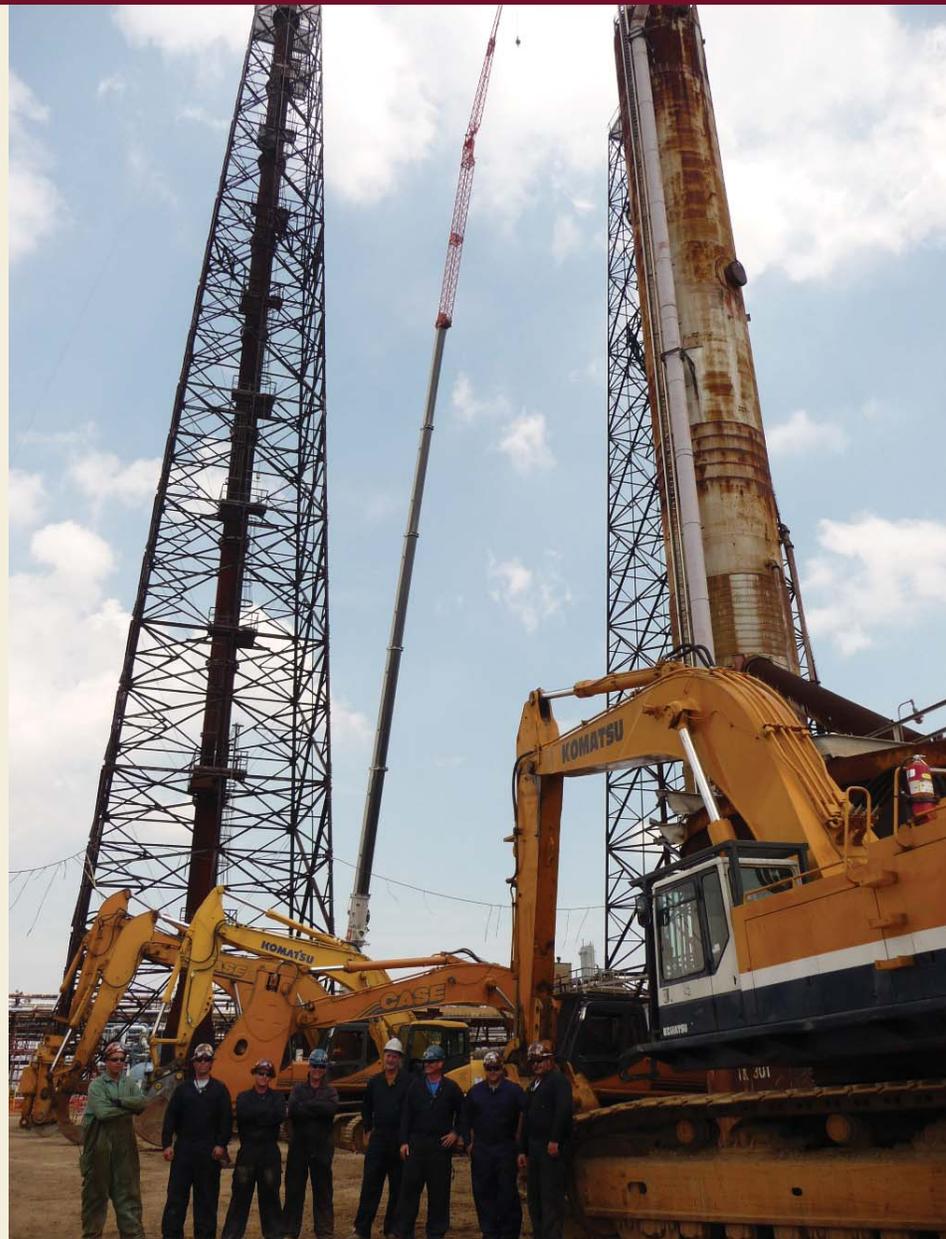
Early-phase dismantling tasks included removal of rail sidings, vessels, piping, and associated equipment in adjacent areas. Once completed, dismantling of the stacks and towers commenced. The project required Baker crew members, suspended in man baskets from two 70-ton cranes, to pre-cut the T-301 tower into three sections using high-pressure water jet cutters.

A 600-ton hydraulic crane was moved in to lower the sections to the ground. The cleared area was then leveled and stabilized to accommodate the 600-ton crane during dismantlement of the twin sulfur stacks and towers.

Dismantling of each sulfur stack began with the installation of spider lifts below the top tower platform. Using oxy-acetylene torches, workers hot-cut holes in 50-foot increments, from which they attached the stacks to the surrounding structure. Once the stack was secured to the structure, the uppermost section protruding above the platform was cut and removed, and crew members moved on to hot-cutting the inner stack into 50-foot suspended sections.

The 600-ton crane and two 190-ton cranes were positioned to commence removal of the structure. The structure was secured to the 600-ton crane, and **workers suspended from the two 190-ton cranes proceeded to hot-cut the structure into five 50-foot sections.** One by one, each structure/stack section was carefully lowered to the ground. The final ground level section was dismantled using excavators equipped with shear and grapple.

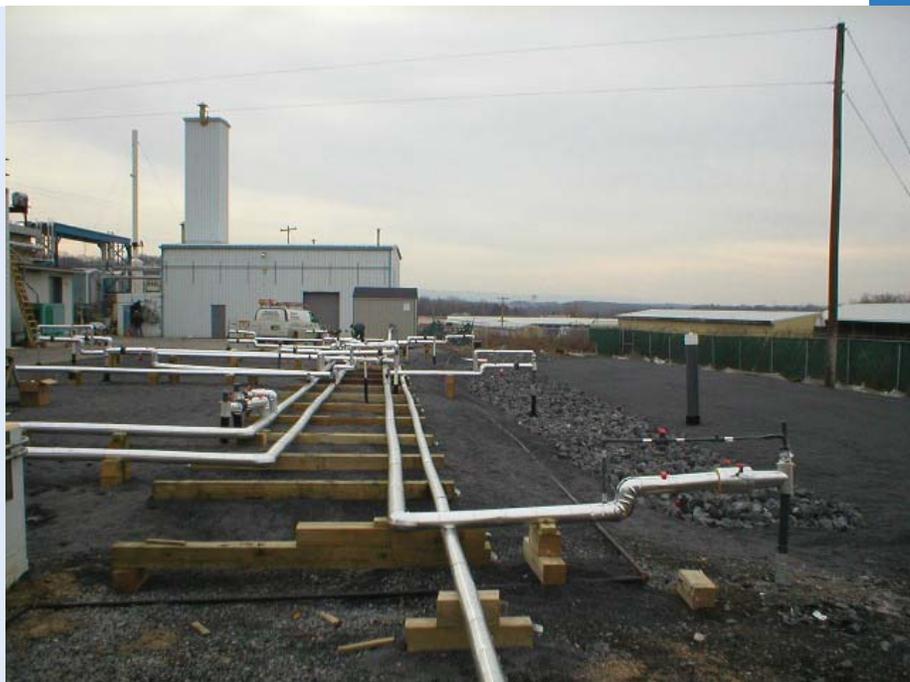
SVE is accomplished by drilling one or more extraction wells into the ground to a depth above the water table and a vacuum pump is attached to pull air and vapors from the soil to the surface for treatment. The extracted

off-gases are first piped into an air-water separator to remove moisture from the air, then processed to recover the contaminants. Activated carbon filters are usually used during this step, but other methods include biofiltration, in which bacteria is used to break down the vapors into gases, and heating the off-gases to high temperatures to destroy the vapors.

In cases where contaminants lie below the water table, a process called air sparging is used in tandem with SVE. Injection wells are drilled to a level beneath the water table and an air compressor pumps air through the wells into the groundwater-soaked soil. This causes vapor-laden air to bubble up through the groundwater and into the soil above the water table, where it is extracted using SVE.
