# *the* **OUTRIGGER**

OCTOBER 2019

## **PIER 42 DEMOLITION - Making Way For The Future**

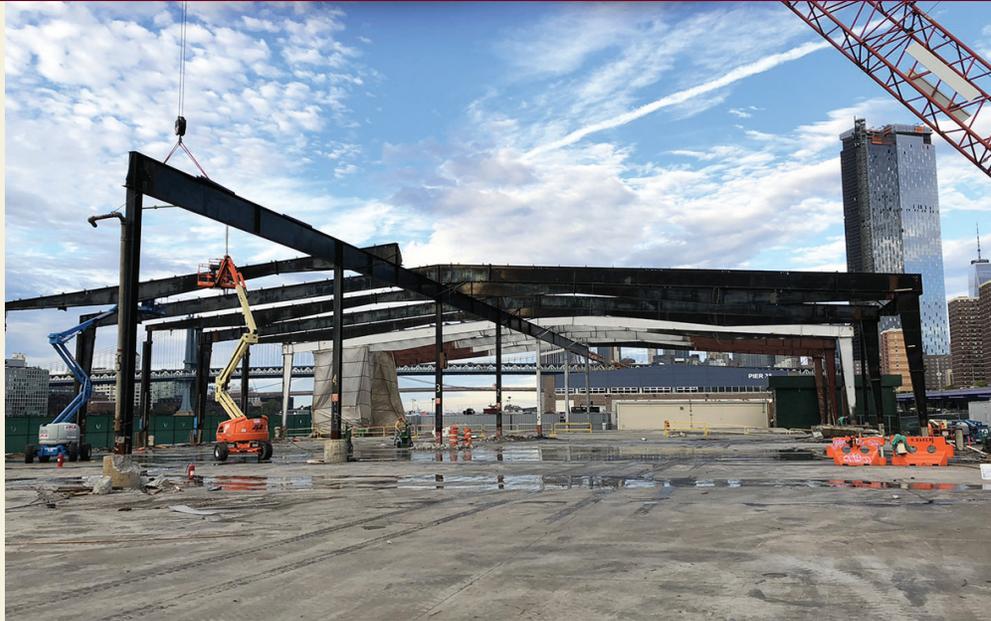
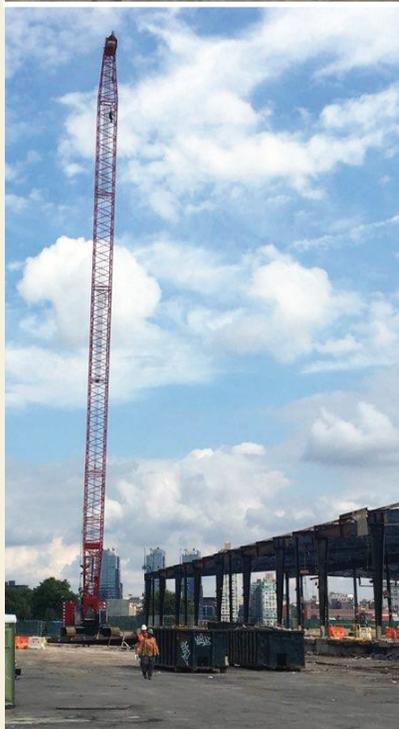
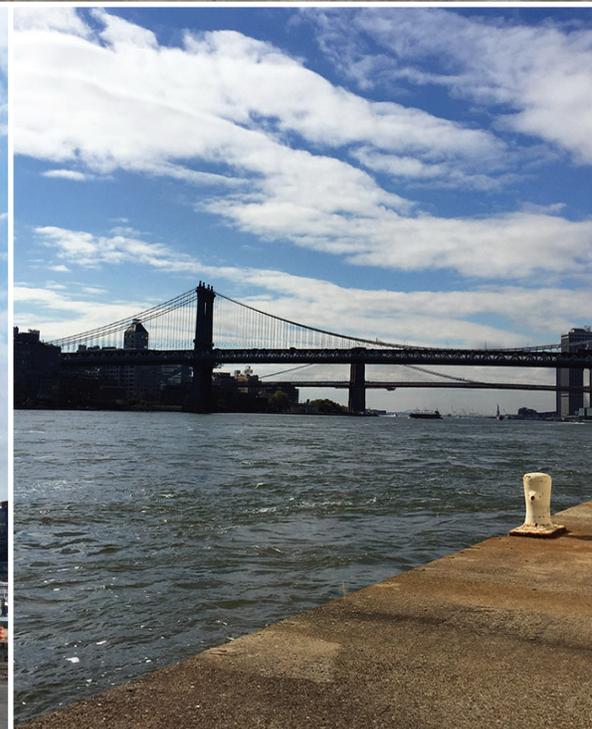
Equipment utilized to take down the 80'W x 30'H x 240'L warehouse built in 1964 included a 130-ton crane with 170-foot boom, several excavators, and a lull. The first task performed was the removal of metal panels enveloping the building. Heavy equipment was used to remove panels from three exterior walls, but the fourth 240-ft wall facing the river had to be unbolted and stripped by hand because it could not be accessed by large machinery. Regarding: structural framing: the steel structure consisted of moment frame construction. Dismantling required an engineered systematic sequence removal plan in order to ensure that structural integrity would be maintained throughout all phases of dismantlement. The process took three to four weeks to complete.

The project also entailed removal of the sprinkler system, water lines, and conduit from the interior of the building. Also demolished was a two-story cement block structure that stood inside the building. Next, demolition and rigging crews carefully dismantled the steel skeleton of the building and removed sections by crane. An end section of the building was left intact to serve as part of a planned amphitheater. With the removal of all demolition debris, R. Baker & Son completed our assigned task safely and successfully, leaving a clean, open concrete pad ready for the next phase of the project.

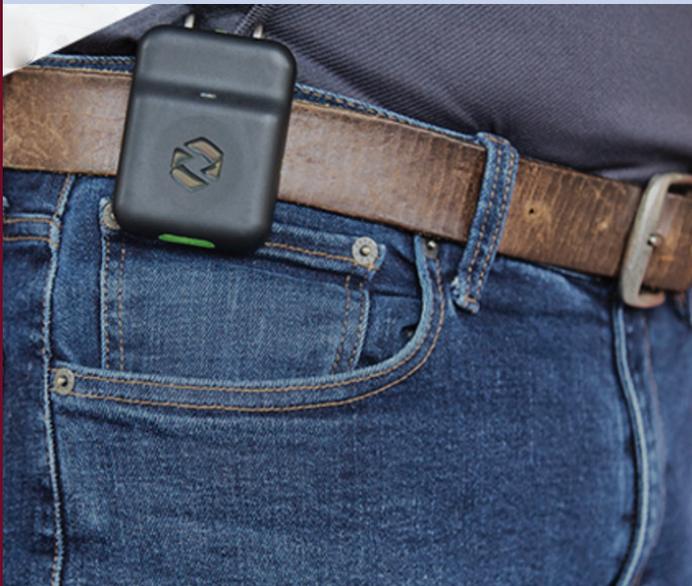
Triax first released the Spot-r Clip, a small, belt-mounted device, in 2016. The Clip automatically connects to the Spot-r network when a worker arrives onsite and tracks their movements in real time until they leave. It automatically detects when a worker has tripped or fallen and instantly alerts supervisors to their exact location, distance of the fall, and how hard they landed, improving injury response time by up to 91%. It also includes a feature that allows workers to easily report safety hazards and incidents. The clip helps maintain jobsite security, and certification information for individual workers is instantly accessible, helping to ensure regulation compliance.

The Spot-r EquipTag works in tandem with the Clip to monitor equipment location, usage, and operator identity. The EquipTag can detect when and record workers in proximity to the tagged equipment and sends an alert when an operator is unauthorized or unknown. It also records operational history, such as active and idle time and hours logged by individual workers.
